Salmonberry Trail Valley Segment Base Conditions Report

Prepared for
Oregon Parks and Recreation Department

August 2017

Prepared by
Parametrix

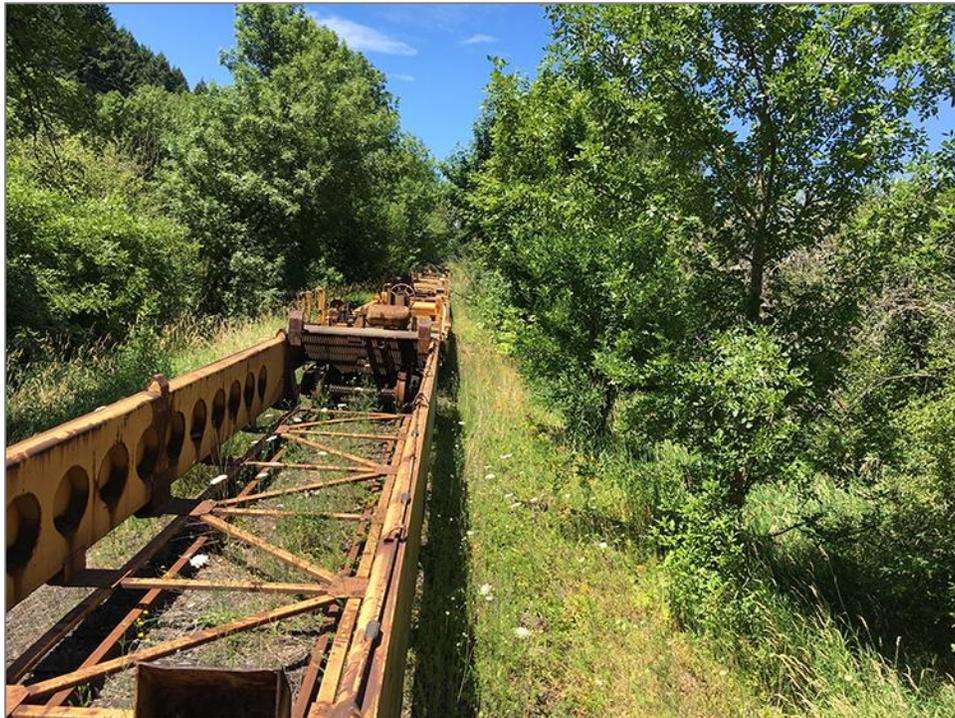
- **Blocked Rail Line** – From Manning to within a mile of the City of Banks, flatbed rail cars are stored on the rail line. This circumstance, combined with higher elevation rail berm fills with steeper side slopes, a narrow 8- to 9-foot-wide rail bed crown, encroaching vegetation, and drainage ditches and streams on either side of the rail, made consistent access difficult. This Salmonberry right-of-way section was therefore often observed from the abutting and parallel BV Trail.

Photograph 6-1. Stored rail cars between Manning and Banks

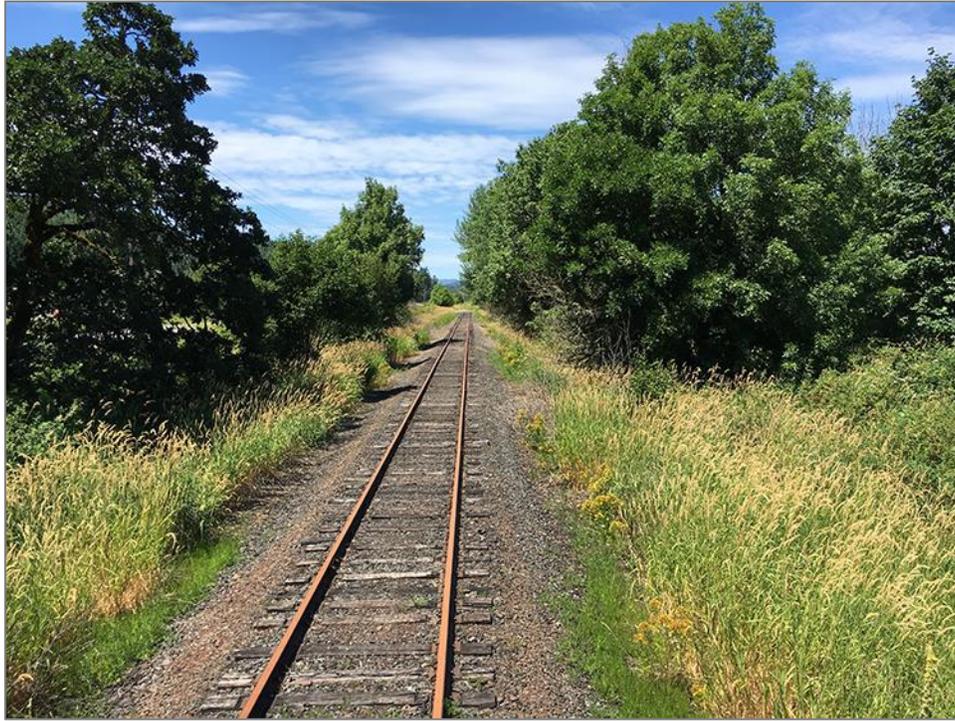
The only rail cross sections relatively free of major vegetation encroachments were typically short sections where local landowners (and in one case, OPRD) had done some clearing, or where roads crossed the rail right-of-way. The only fully clear section of any length was the last mile of the rail right-of-way before entering the City of Banks. Presumably this area is kept clear to ensure that the stored rail cars (see above) can be easily and quickly removed if needed.

Photograph 6-2. Only extended clear section of rail (near Banks)

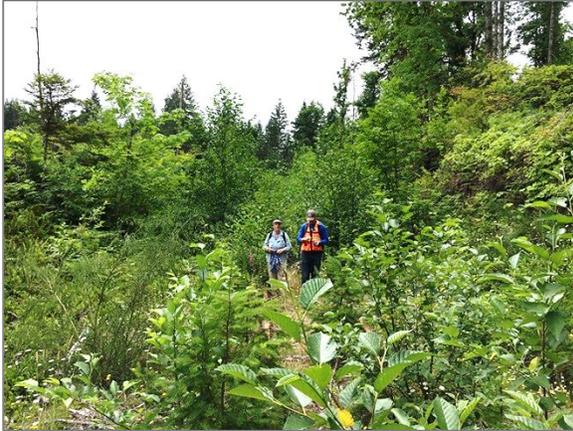
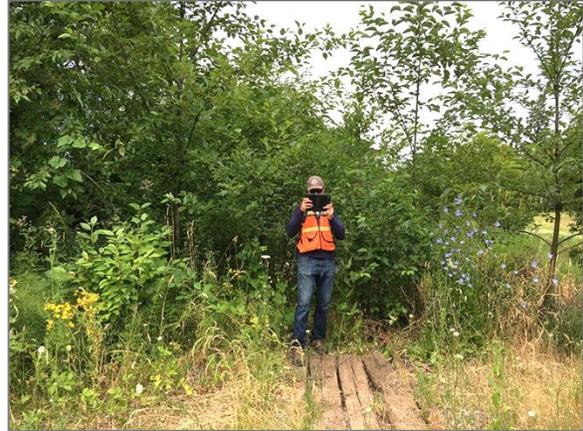
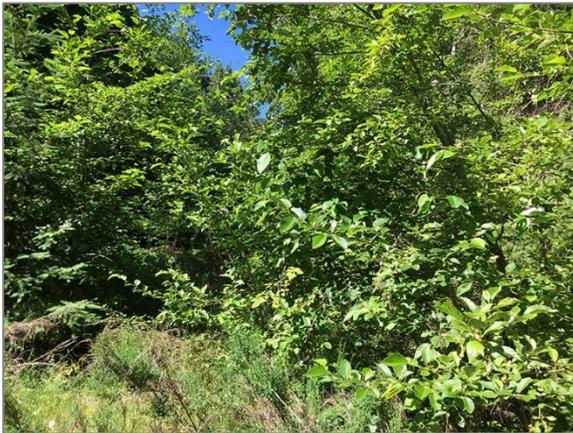
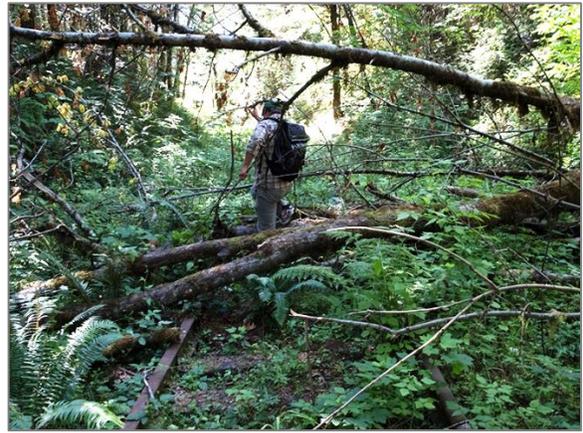
- **Vegetation** – Most significantly, the ubiquitous and ever-increasing encroachment and growth of many species of vegetation into the rail right-of-way, and especially within existing rail line cross sections, made passage very slow and in some places impossible. Blackberries clogging valley floor sections of the rail right-of-way proved particularly hazardous. Vegetation severely limited the field team’s ability to accurately assess (or even see) factors such as rail berm fill conditions and width, culvert and drainage function, and topographic variations.

Clockwise from upper left, Photographs 6-3, 6-4, 6-5, and 6-6. Examples of encroaching vegetation

Encroaching vegetation and other damaged areas (such as landslides) should be a serious concern to the future engineers, builders, and operators of the Trail. Recommendations and estimates in this Valley Study regarding current conditions, needed repairs, infrastructure replacement or upgrades, and/or re-use of existing structures, may be obsolete by the time of actual Trail construction. The problems with accessing and viewing many right-of-way sections (as discussed above) also mean that some findings and data coming out of the Valley Study should be considered only as starting parts, subject to further inspection, survey, and assessment at the time of design and construction.

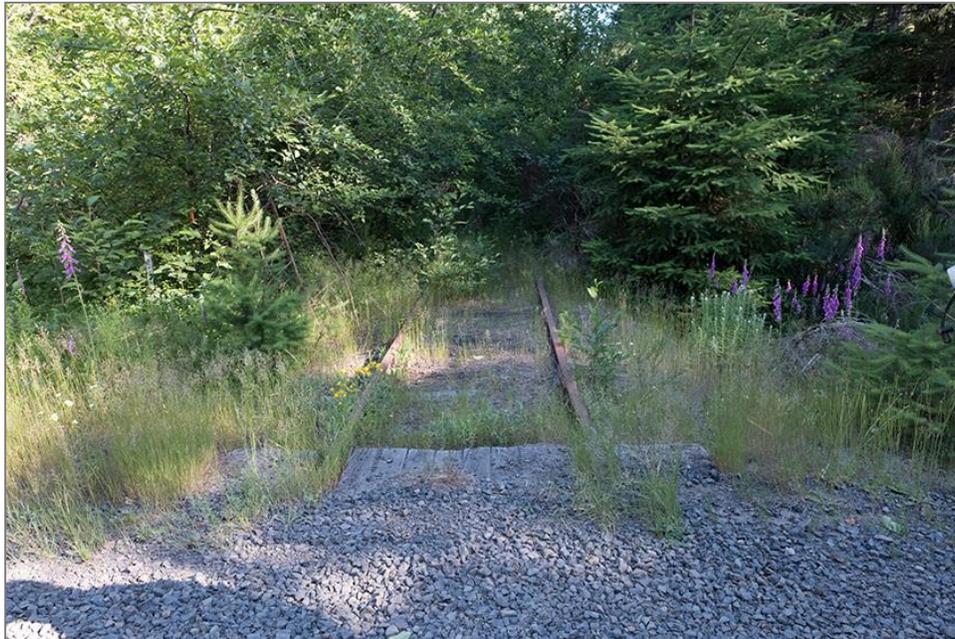
- **MP 797.28 to MP 796 (east of Cochran Pond at NW Cochran Road crossing of rail corridor to Gales Creek Trail)** – This area is outside of the original study area boundary and is also beyond the west limit of the possible study area expansion that was initially contemplated in advance of the field reconnaissance. With no prior information on conditions along this right-of-way section, and at the time no experience in making passage through the right-of-way’s vegetation-congested areas, plus observations made early on July 6 in driving along local roadways, the walking of this section was deferred. If one of the connecting trail options west of the Gales Creek Trail is deemed most viable as part of the upcoming Trail Alignment and Type Analysis phase, this particular section of rail may have to be revisited.

Photograph 6-7. Disappearing crossing of NW Cochran Road

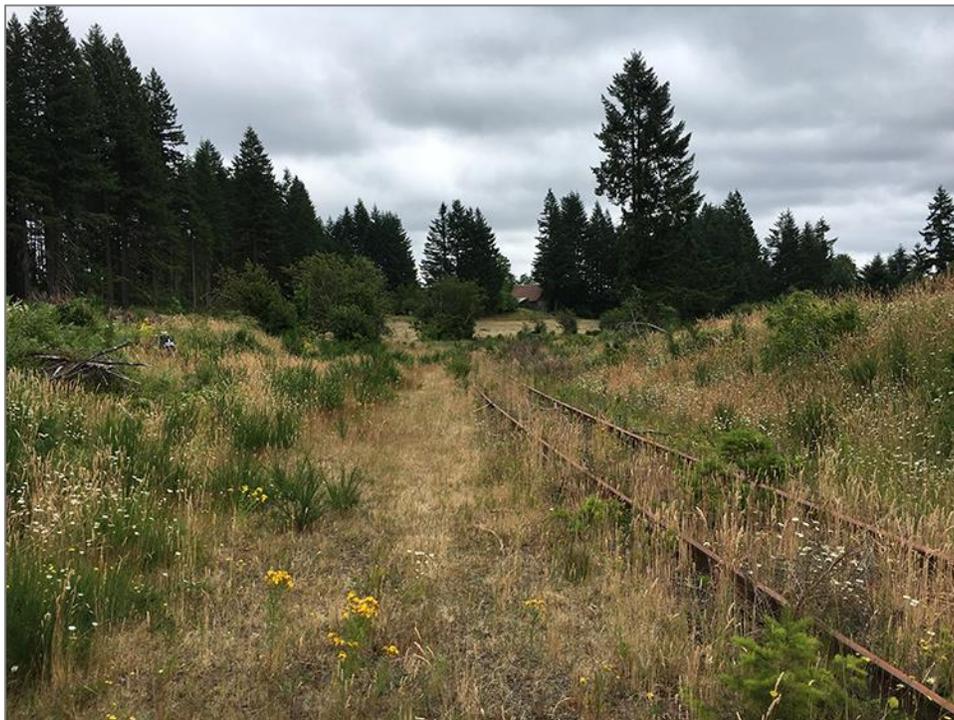
With these circumstances in hand, the decision was made to defer what would probably have been a 3- to 4-hour effort. The field team was, however, dropped off at MP 784.9 (the most easterly rail crossing on NW Scofield Road) and walked the rail right-of-way from this point to the bridge over OR 47 (MP 783.55). This section of right-of-way, at least in part, appeared to have been intermittently cleared by adjacent farmers.

Photograph 6-8. Relatively clear areas near Scofield crossing

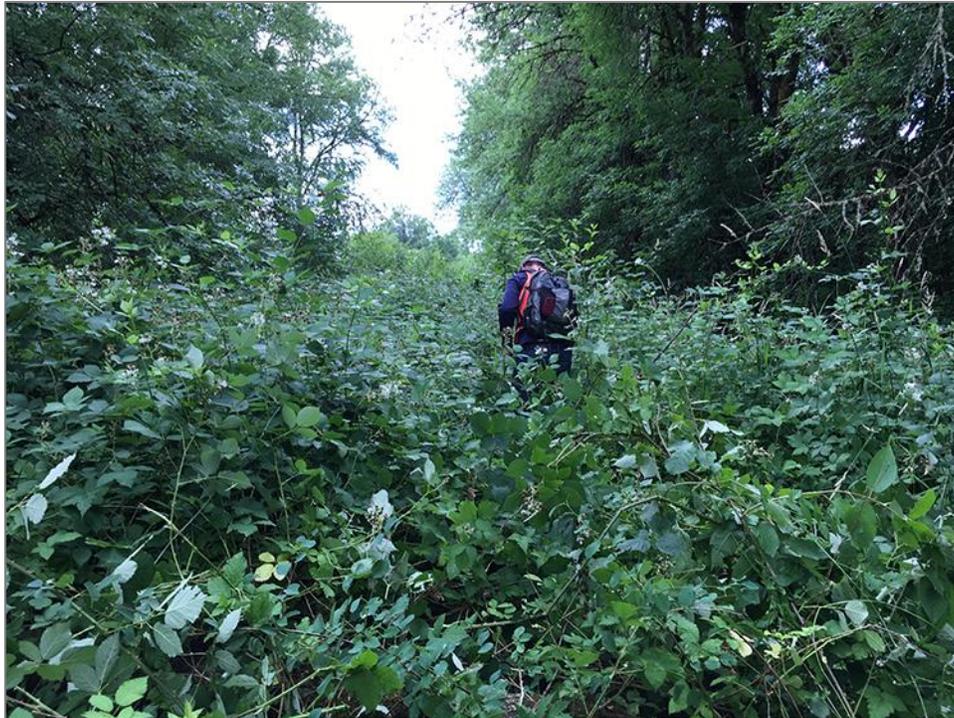
- **MP 781 to MP 779.27 (Buxton to near Manning)** – In advance of the field reconnaissance, spot inspections raised some hope that this section of the rail corridor would be less overgrown than were upper study area sections. However, except for areas at road or driveway crossings, this generally proved *not* to be the case. The dominant invasive vegetation was blackberry. This rendered some areas along this 1.7-mile-long section virtually impassable and significantly slowed progress in other sections. The field team was, at times, forced to step outside of the rail right-of-way and into farmed field edges to move forward. All six rail trestles between Buxton and Manning were, however, reached and inspected.

Photograph 6-9. Dense blackberry growth

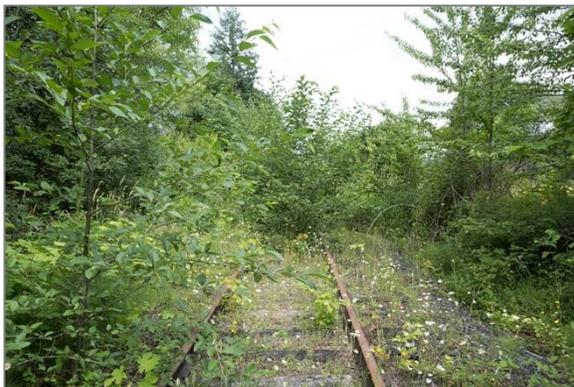
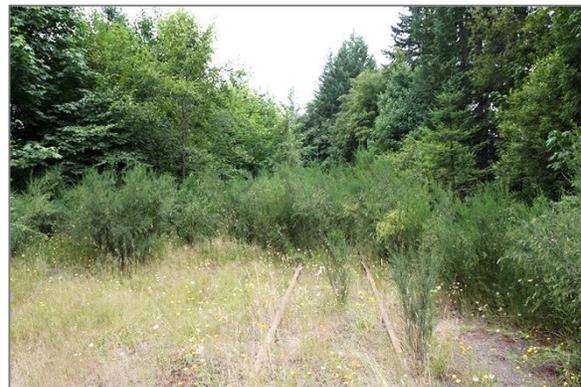
The single most defining condition along the rail right-of-way is the amount, size, density, and diversity of plant species that have grown up within the rail right-of-way and between the rails in less than 10 years. The density and extent of vegetation was a significant challenge in observing conditions in the course of the July 2017 field reconnaissance. For example, the Concept Plan identified a need for a major culvert repair at Step Creek (MP 795.5). The field team was not able to observe this culvert at stream level.

Photographs 6-15 and 6-16. Additional examples of encroaching vegetation

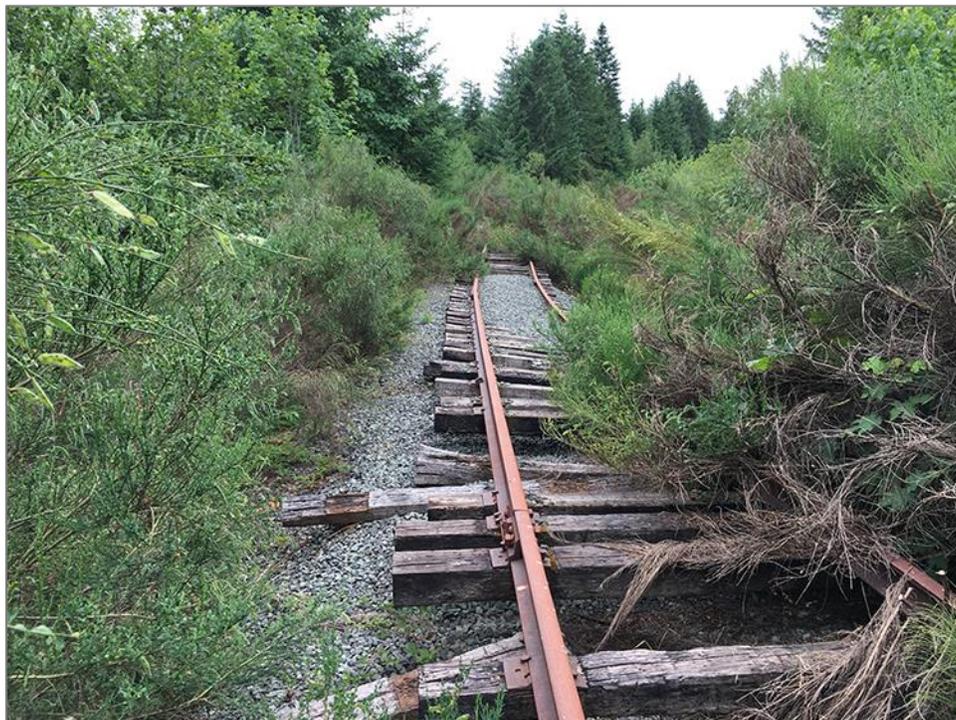
- **MP 790 and Walcott Tunnel west entrance – Mild.** Two small landslides.
- **MP 789.2 (east of Walcott Tunnel) – Moderate.** The rail berm fill has partly collapsed at this point, leaving rails and ties cantilevered over or hanging in the air. This area did not, however, appear to be within any sort of perennial drainage, so the damage may be the result of a landslide occurring under the rails. Plus, some new gravel and rock has been placed along this section, but otherwise there is no evidence of other activities such as rail tie repairs or vegetation clearing, so the origin and purpose of the new rock is something of a mystery.

Photograph 6-17. Previously undocumented damage east of Walcott Tunnel

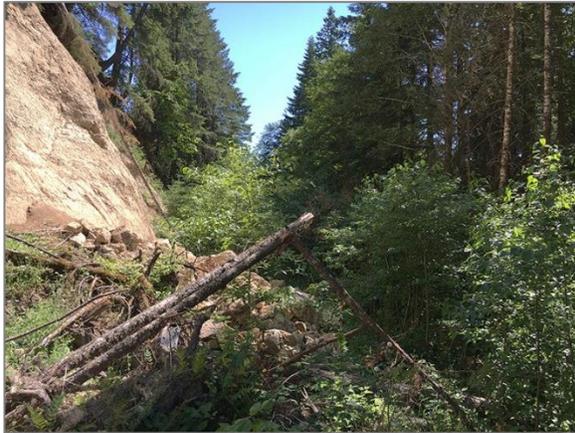
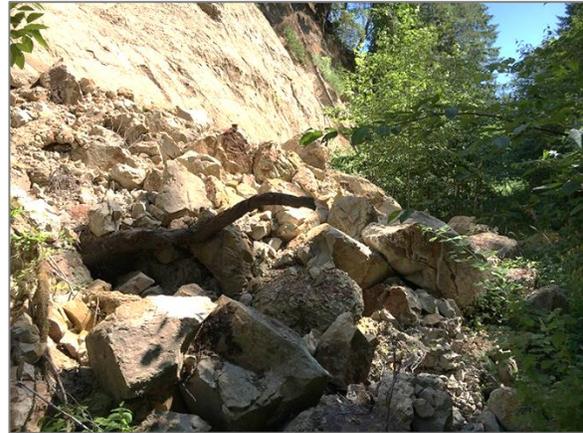
- **MP 783.4 (east and south of OR 47 trestle) – Severe.** The reconnaissance field team found a major landslide (approximately MP 783.4) near the east end of the long and very high OR 47/West Fork Dairy Creek trestle. This landslide and rockfall extend over the rail right-of-way and the rail line for approximately 200 linear feet. Our field assessment suggested that the cost

Aerial photography (no date) reproduced in the Concept Plan atlas suggests that some landslide activity may have already been underway at the time the Concept Plan was developed. Most of this landslide, however, appears to be quite recent and may still be active, perhaps having been triggered or made worse by major 2016 and 2017 winter storm events.

Photographs 6-18 and 6-19. Major new landslide near the OR 47 Trestle

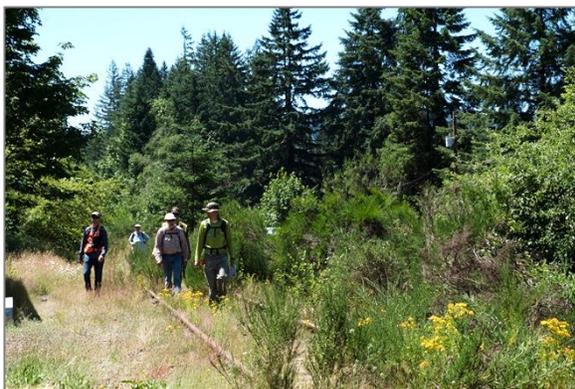
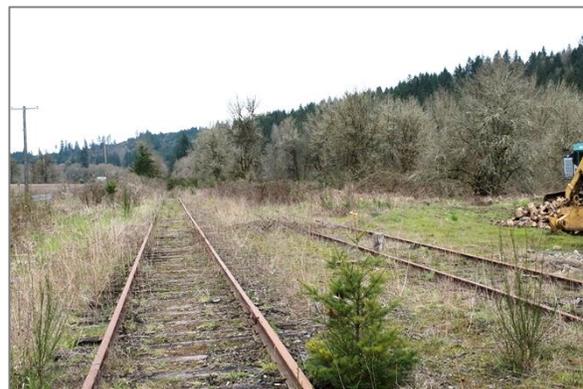
The width and height of the rail berm fill may have a material impact on the feasibility and costs of Trail development. Except for the rail corridor between Buxton to Banks, however, the berm fill is primarily low elevation or essentially at-grade with the immediately surrounding landscape. The crown of the berm is often indistinct due to the original low elevation and/or from minor edge deterioration and major vegetation encroachment over the last 10 years.

Photograph 6-20 and 6-21. Low rail berm

Except perhaps for the Buxton to Banks section (see below), it appears that nearly all areas of the existing rail berm fill can be easily widened to accommodate a 10-foot-wide paved bicycle/pedestrian pathway with 2-foot-wide shoulders.

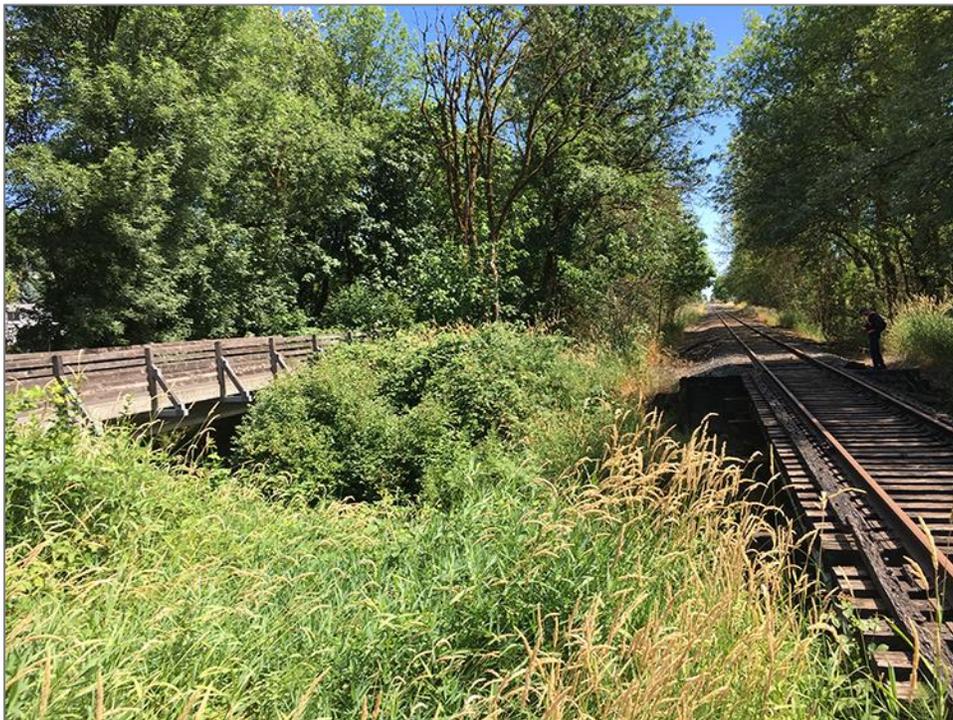
Starting south of the Buxton area and continuing all the way to Banks, the berm fill is generally higher elevation than in the upper sections of study area. The higher elevation rail berm crown is 8 to 9 feet wide, similar to the rail berm crown in many parts of the Coast Segment. The resulting steeper side slopes of these higher berms, combined with the limitations imposed by the immediately surrounding landscape (including drainage courses and ditches, and wetlands and streams) will require more, and more expensive, improvements to achieve a 14-foot-wide bicycle/pedestrian cross section.

Photograph 6-22. Banks-Vernonia Trail alongside the Salmonberry Corridor

These conditions suggest that the widening of the parallel BV Trail, particularly between Manning and Banks, may be a preferable and considerably less expensive alternative to constructing 4 miles of a new, separate parallel trail pathway within the Salmonberry rail corridor. This solution was recommended in both the 2013 Feasibility Study and 2015 Concept Plan.

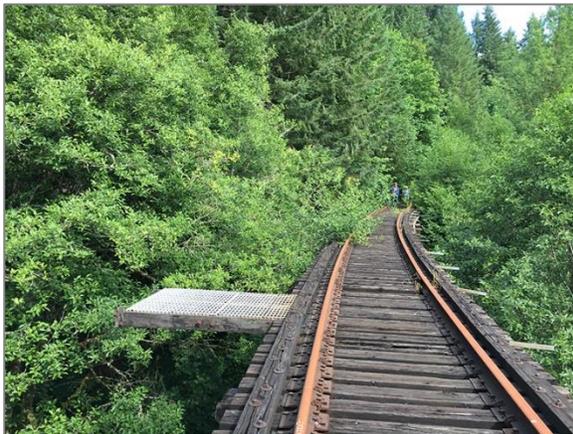
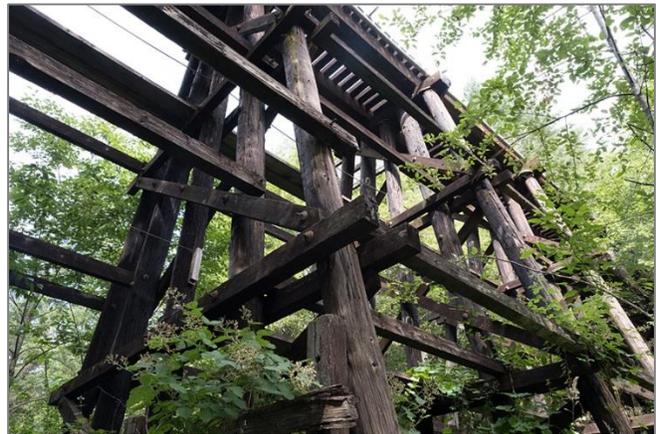
Photographs 6-23 and 6-24. Williams Creek Trestle

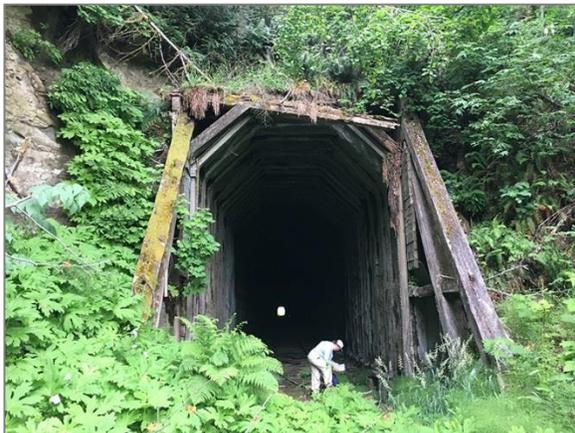
Photograph 6-25. East entrance to Walcott Tunnel

Even at this Base Conditions phase, we strongly recommend that POTB erect barriers to block unauthorized Walcott Tunnel entry, and also post signage at all probable rail right-of-way access points within 2 miles of either end of the tunnel informing visitors that the right-of-way is off-limits and that the tunnel is dangerous and blocked.

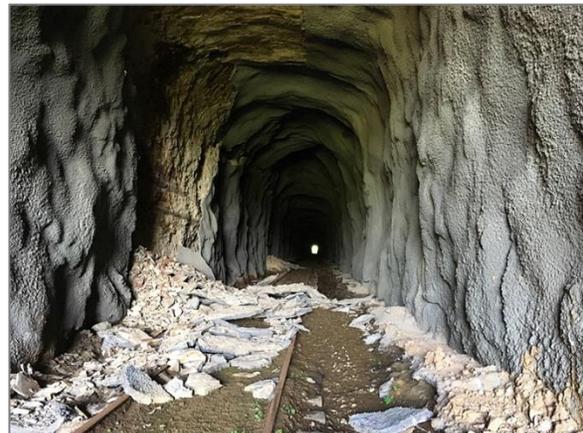
Photograph 6-26. Interior of Walcott Tunnel

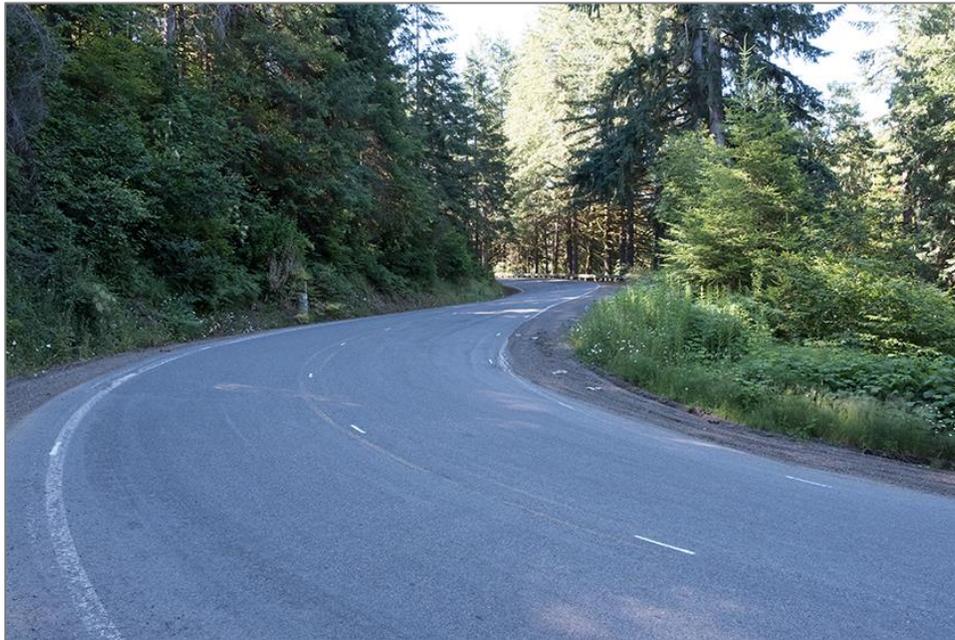
- **NW Timber Road** – NW Timber Road consists of two 11-foot-wide paved driving lanes. Shoulders are narrow to nonexistent with only a few areas sufficiently wide to accommodate safe vehicle pull-outs. Steep slopes, both downhill and uphill from the sides of the roadway, limit possibilities for additional road or shoulder widening (or a new bike lane) without considerable improvements and expense. NW Timber Road also frequently changes grade and winds around curves making for very short sight lines. As this roadway approaches the intersection with NW Strassel Road, the grade flattens and the surrounding landscape widens out to some degree.

Photograph 6-28. NW Timber Road

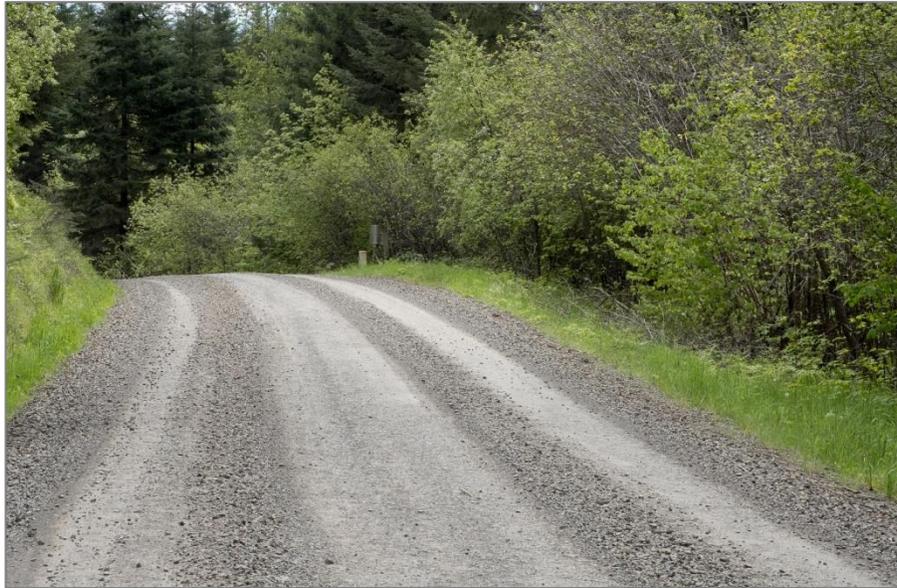
Photograph 6-29. NW Strassel Road

There are also many more homes and farmlands along NW Strassel than is the case with NW Timber Road. Widening of shoulders or creation of bike lanes would therefore be more feasible and economic than with NW Timber Road, although if this roadway is maintained with a gravel surface, the usefulness to bicyclists (and walkers) would be somewhat limited.

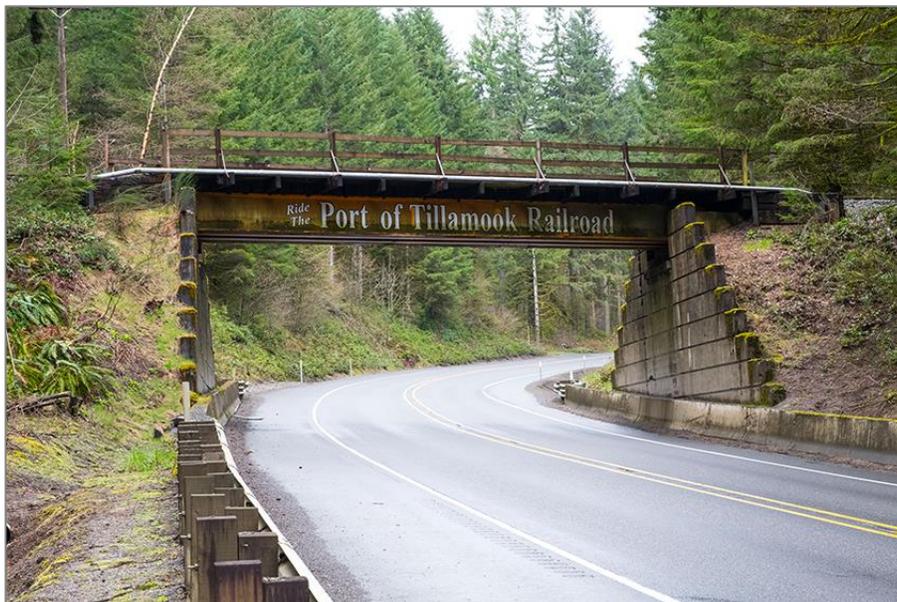
- **US 26** – The rail line crosses over US 26 on a 55-foot-long steel bridge at MP 787.7.

Photograph 6-30. US 26 Bridge

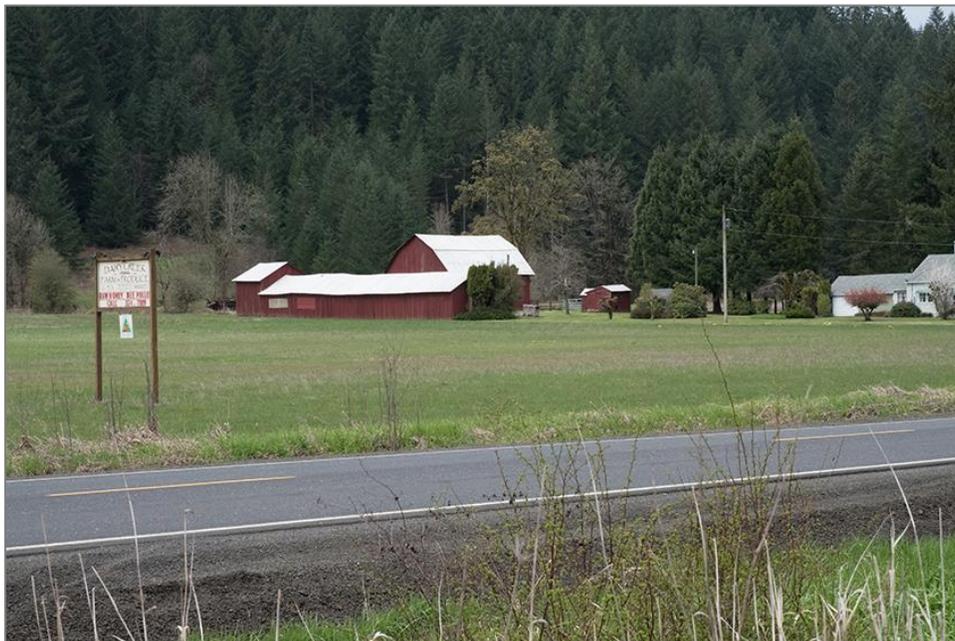
Photograph 6-31. View from Fisher Road/OR 47 Intersection

One branch of NW Fisher Road crosses through a small residential area and then heads downhill on a curve to intersect with the rail right-of-way at MP 781.2 and OR 47. NW Bacona Road and this portion of NW Fisher Road are identified in the 2015 Concept Plan as a “potential short-term connection to the BV Trail” for “on-road bike use.”

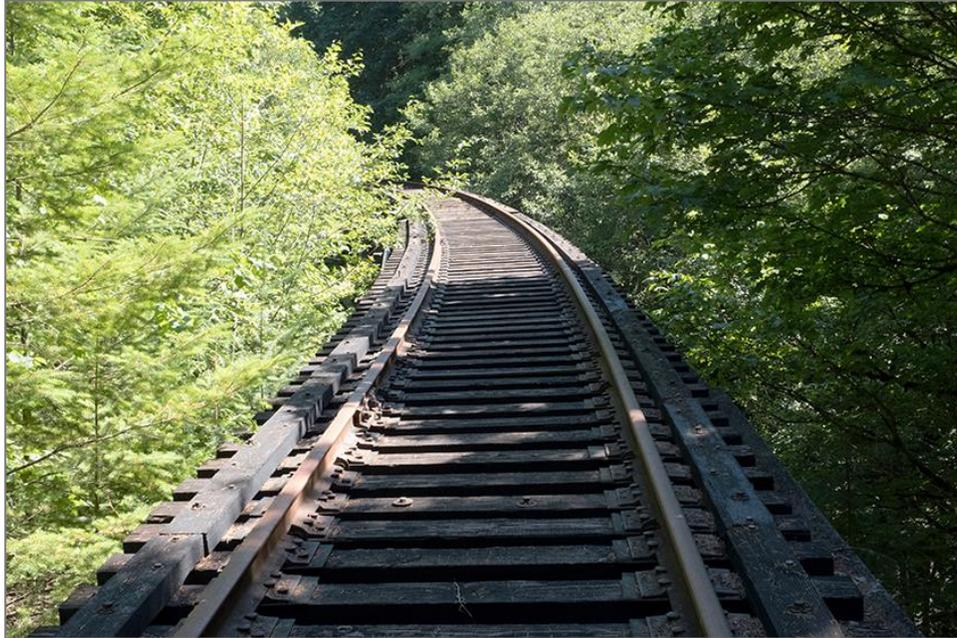
- **Camp Creek** – The primary significance of this creek to future Trail development is the re-use of the 291-foot-long Camp Creek Trestle at MP 783.91 (this creek and structure is named Canyon Creek in FEMA records). A tributary of Camp Creek also crosses under the rail in a culvert at MP 785. Another Camp Creek tributary crosses the rail right-of-way at MP 784.3.

Photograph 6-35. Camp Creek Trestle

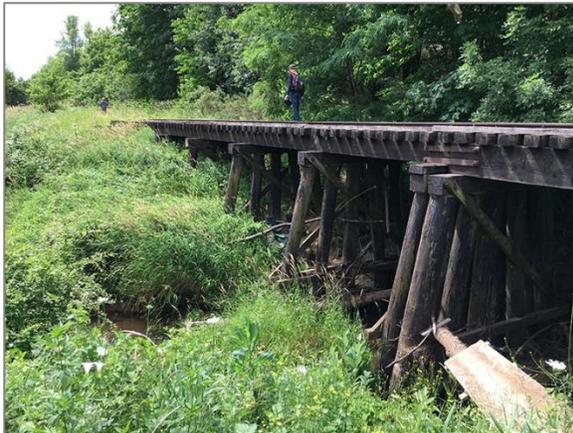
Photograph 6-36. Trestle across West Fork Dairy Creek

- **West Fork Dairy Creek** – Dairy Creek and its West Fork are major tributaries of the Tualatin River. West Fork Dairy Creek closely follows the alignment of OR 47, as well the Salmonberry rail right-of-way, from Stub Stewart State Park to the City of Banks. From the rail bridge/trestle crossings of OR 47 and the West Fork Dairy Creek at MP 783.55, West Fork flows between OR 47 and the rail corridor until meandering over to the west side of OR 47 around MP 783. This area is heavily forested. From MP 783, the rail corridor crosses the West Fork Dairy Creek five times south of Stub Stewart State Park. This last reach flows through agricultural lands.
