Appendix A

Valley Segment Base Conditions Maps

**Salmonberry Trail Valley Segment Study
 BASE CONDITIONS**

Figure 1: Cochran Road Crossing of Rail Corridor (MP 797.28) to MP 794.56

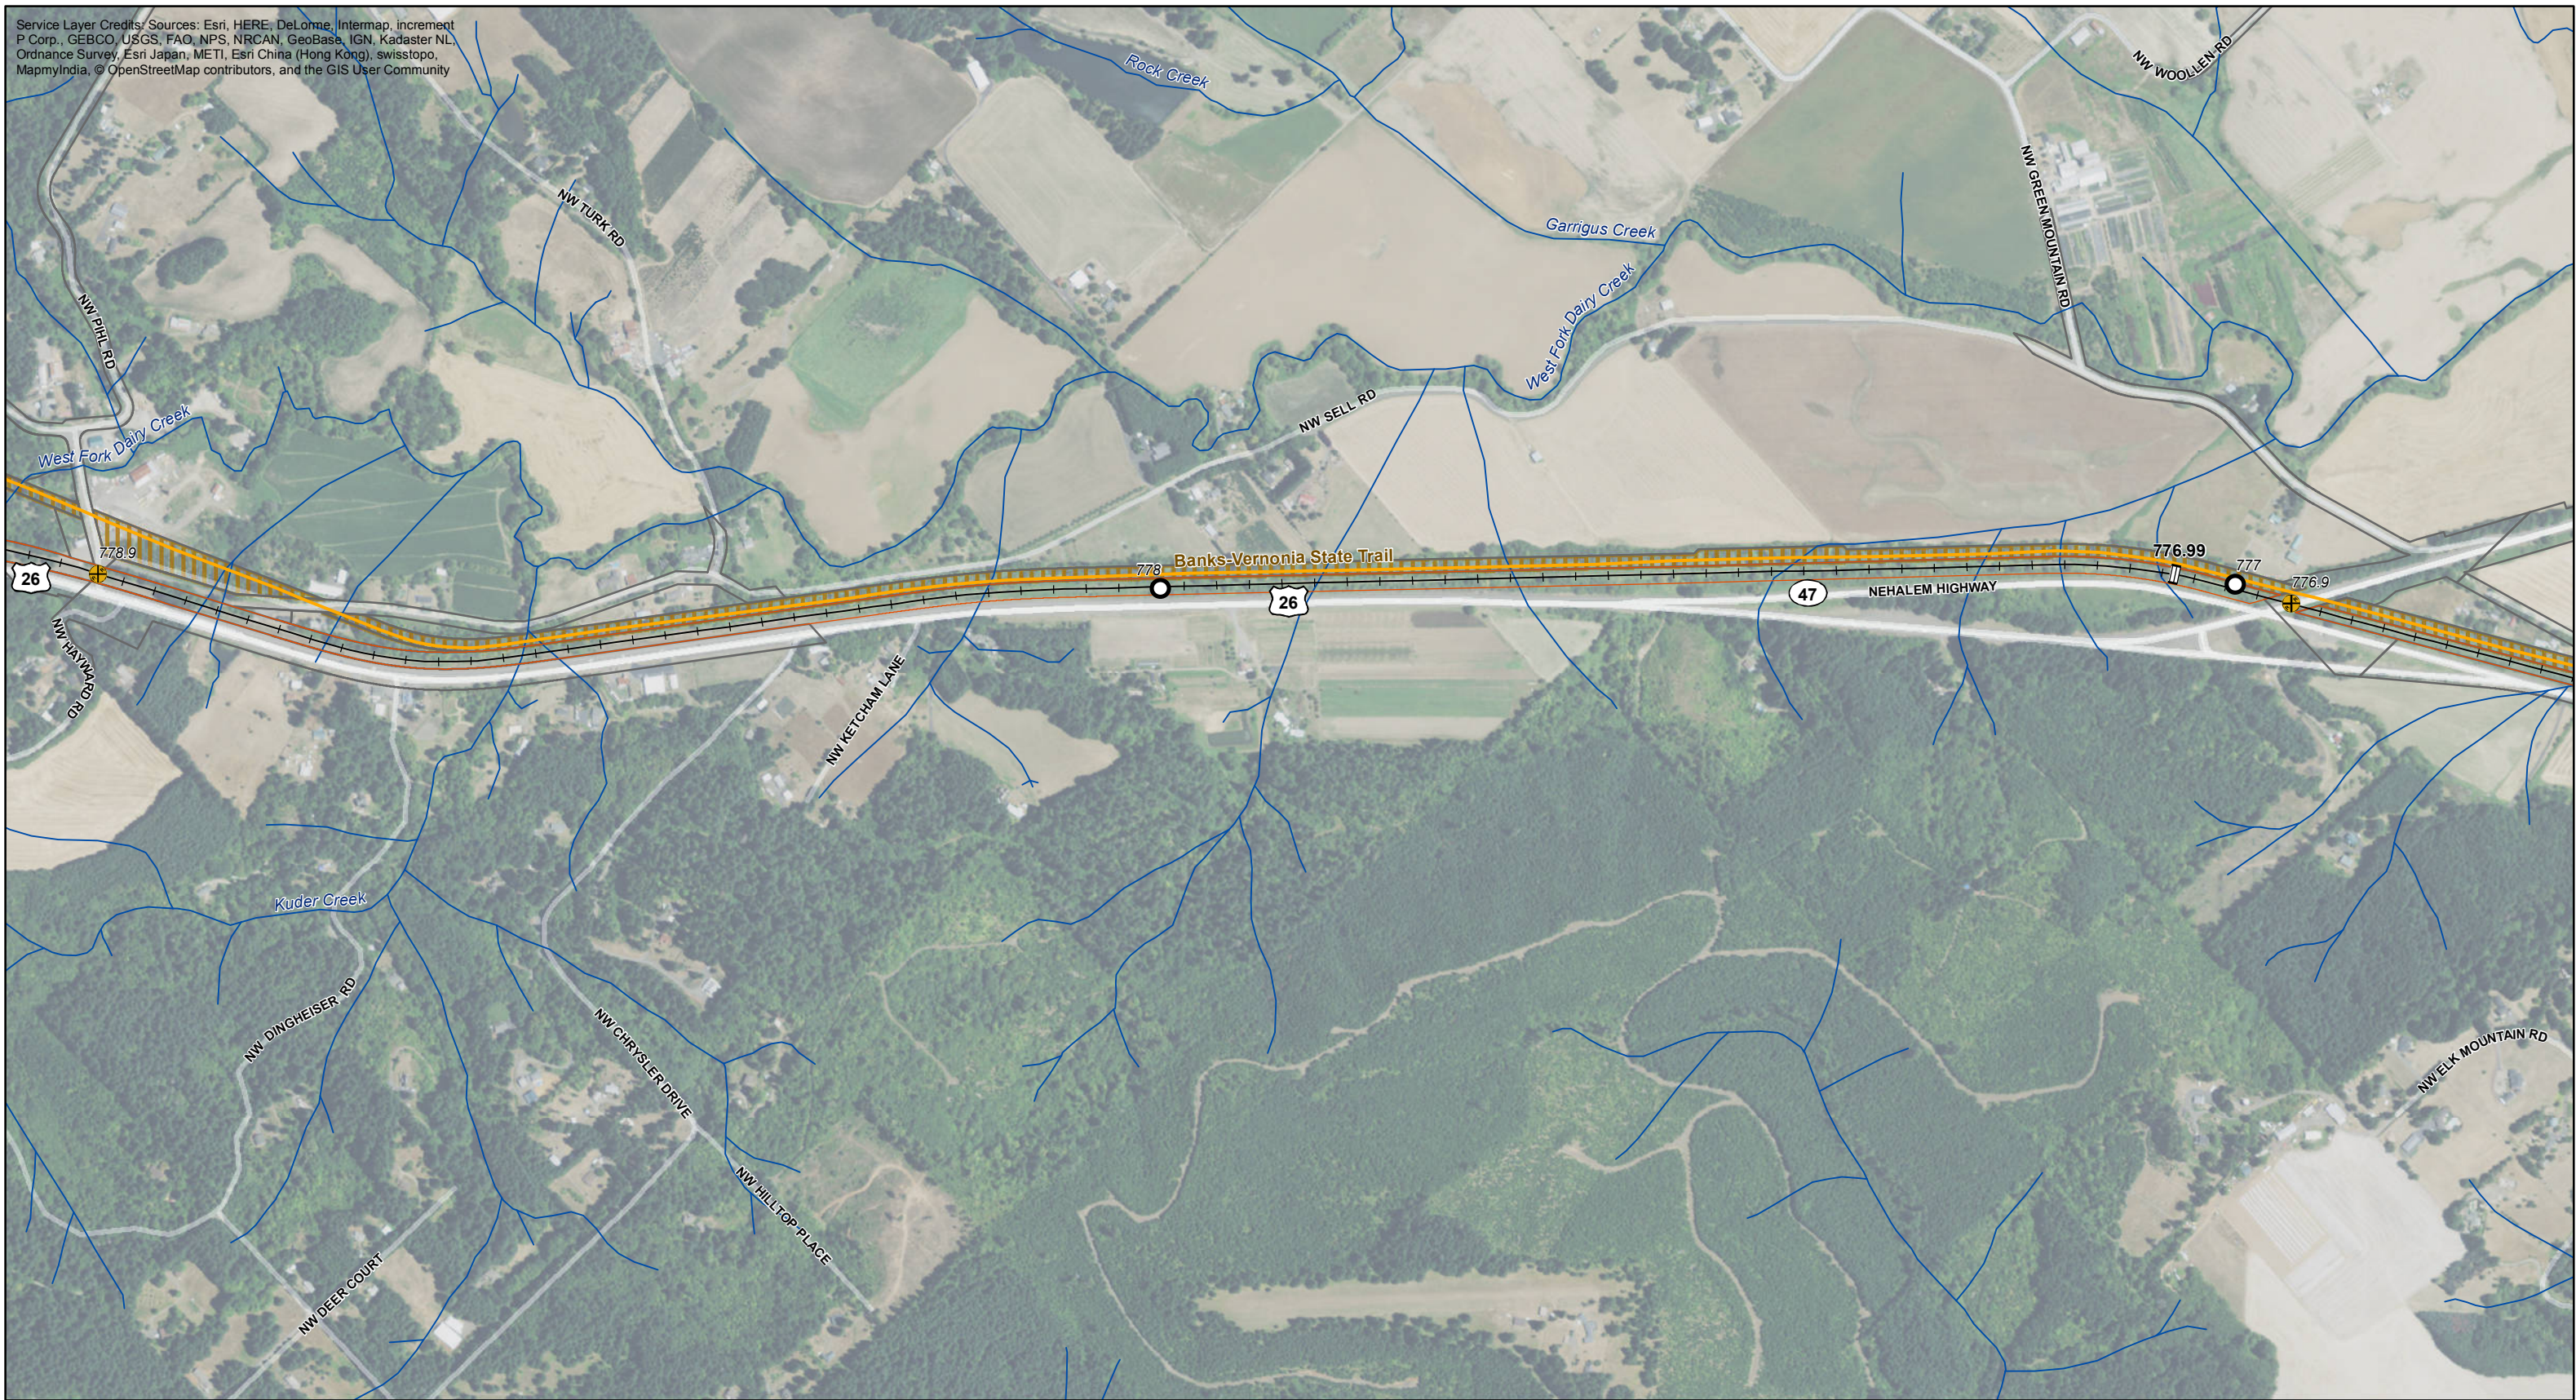
Figure 7: MP 778.9 to US 26/OR 47 Interchange (OR 776.99)

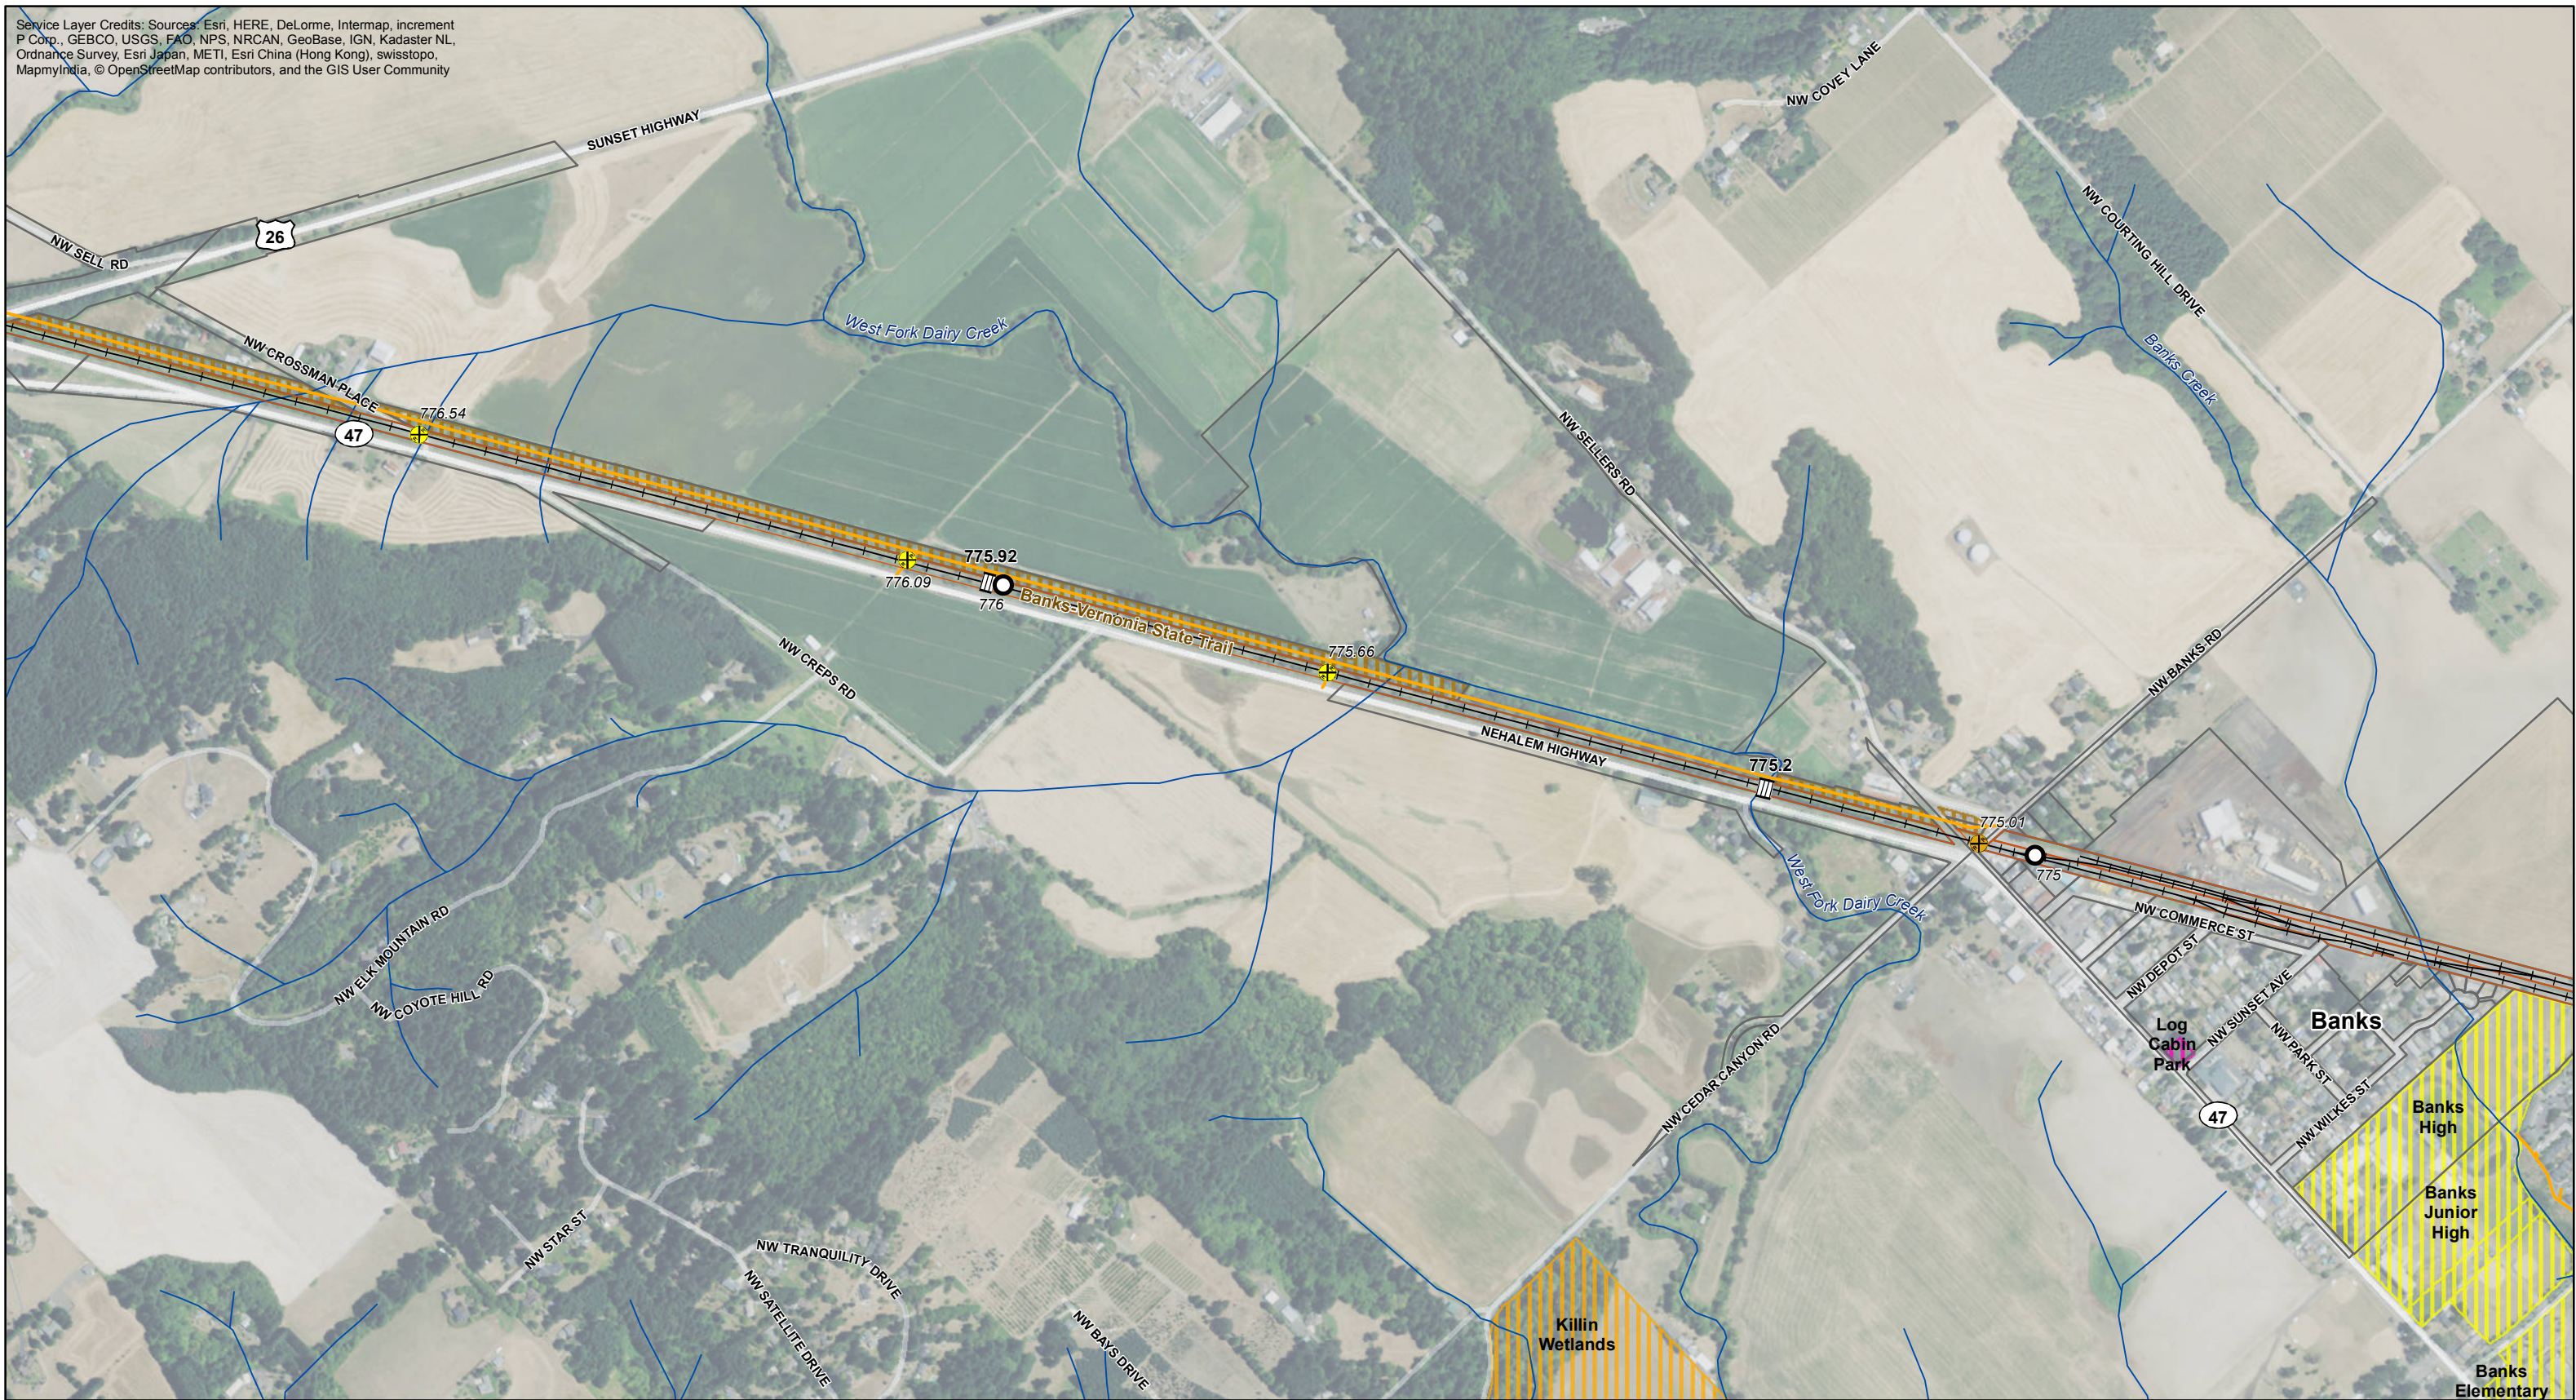
Figure 8: MP 776.99 to north end of City of Banks (MP 775)
